THE OFF-SIDE UNDO

October 2024

English Motoring Club of Mississippi

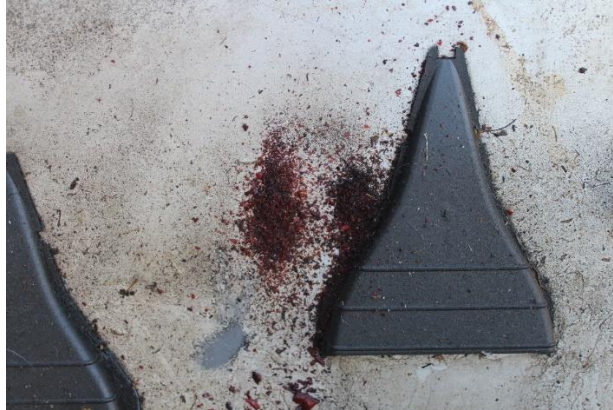
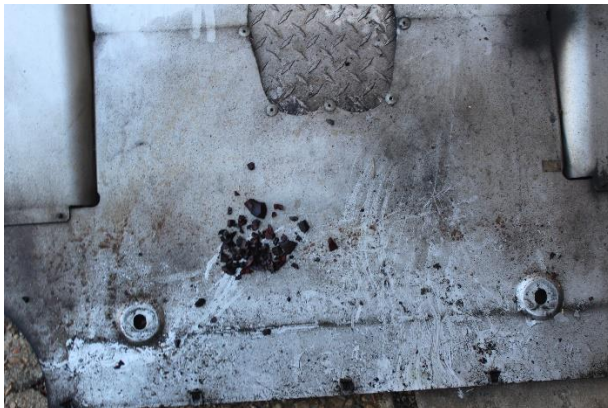
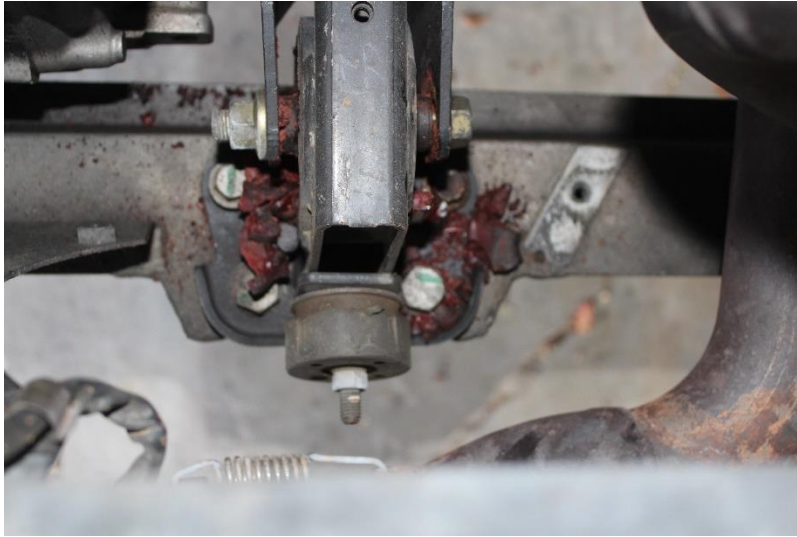
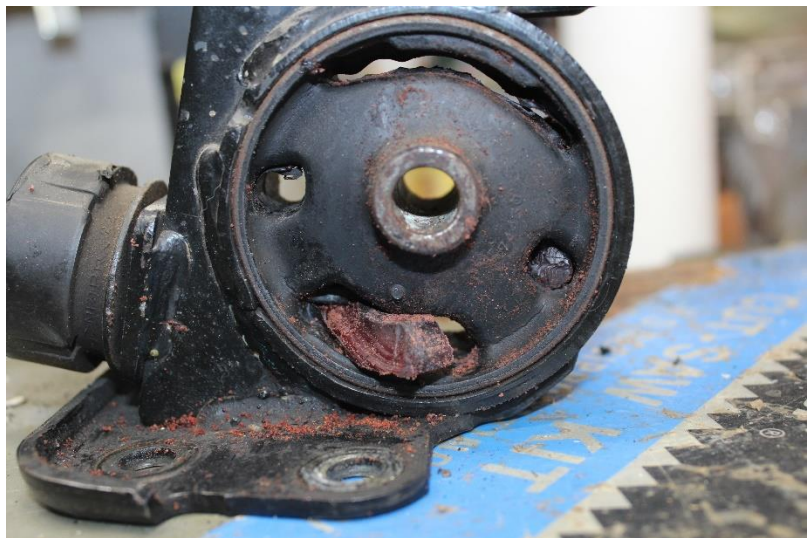
It all started a couple of months ago when I did my usual spring service on the Lotus Elise. Oil change, brake flush and radiator flush. During the oil change procedure, you must remove the undertray in the back of the car. It was then that I discovered that the front and rear motor mount inserts had disambiguated. The actual motor mounts were still intact and only the add-on inserts were destroyed. No other damage was done. (The inserts were added when the supercharger

But it didn't seem so at first. Remnants of failed motor mount inserts were seen as large pieces and dust (arrows) when Richard took things apart to change the oil. Photos by Richard Greene

was installed to counter the added thrust of the supercharger.) Anyway, I replaced the inserts and did all the other procedures at that time. I buttoned up and the car and took it for a short spin to make sure there were no leaks or problems. After returning from the drive, I detected quite a bit of oil on the undertray from a leak. I put the car up on stands and removed the undertray to ascertain where the leak was. Oil was all over the rear engine and tray. My first impression was that my driver's side axle was leaking at the transfer case seal. I figured that I might have disturbed the seal when replacing the motor mount inserts, as I had to raise the engine to slightly to remove the motor mounts. I thought I was extra careful supporting the engine during this to prevent any problems. I cleaned up the oil mess from the engine, tray and axles. I again buttoned up the car and drove it around the block a couple of times. I parked for the night and went to the manuals and my book of maintenance tips to familiarize myself on what it would take to replace the seal. I knew that the axle needed to be removed to get to the seal. I had removed the axles before when I switched out the engine about eight years ago. But

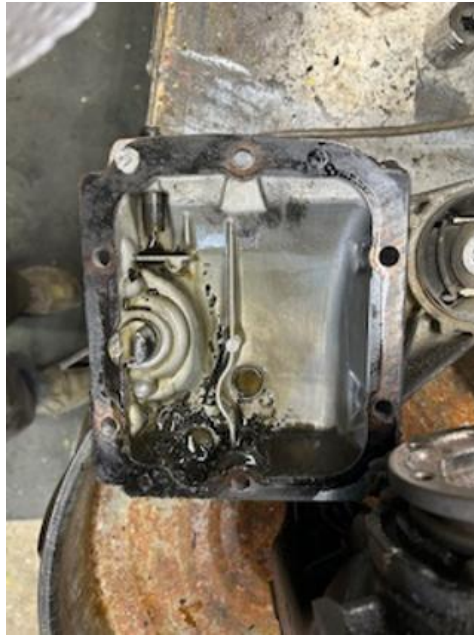
As my Elise was up on Jack Stands for the time being I headed out to my Local British Car Club Meeting in my Z3. About 4 miles out on the interstate the rear end let go with a very loud clunk and much smoke. Pulled over, with a constant clunking, looked in the back but couldn't determine what had happened. Got towed back home and was able to determine that the rear

end main bearing let go.

Got the differential case open on the Z3 differential (transfer case, rear end). The back case cover has a little sludge at the bottom and a few metal flakes on the magnetic probe but nothing like what I expected. I didn't find any metal pieces or parts. I had expected to find parts of the

bearing but none were found. Since I only drove slowly for about 100 yards after it let go most of the damage must be contained in the bearing races and seals. I haven't been able to remove the pinion shaft from the case, as I don't have a bearing press.

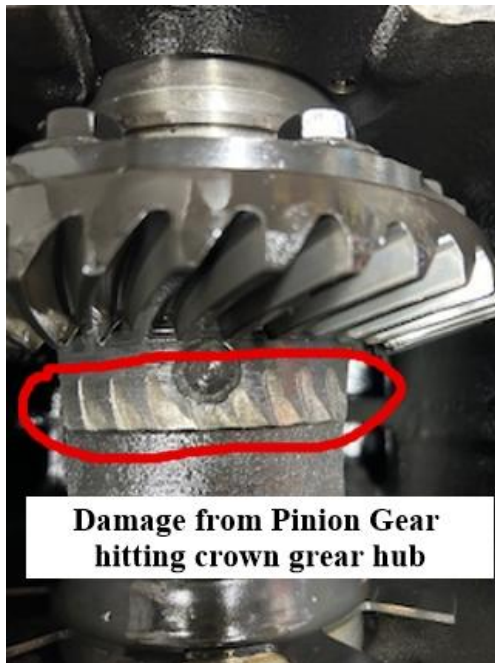
Looking into the case I could see damage to the crown gear hub from the pinion gear hitting it due to the bad bearing. Damage is very limited due to the fact that I didn't drive the car once it let go. The actual pinion gear and crown gear had no damage and perhaps a new pinion bearing, and seal is all that is needed. Of course, I need to figure out how to remove the pinion shaft, pinion bearing and seal to know for sure. Without a shop press I haven't had any luck getting them out.

Here you can see where the pinion gear hit the carrier gear hub causing the marks as noted. They are very slight and don't seem to have caused any damage outside of the superficial scars. I have a half-case coming in early next week and between the two I should be able to get a good rear end ready to install. The half case will have the pinion gear, shaft, bearing and seal already installed and should be a simple job to put back together again with new fluid and gasket. Once I get all that done, I might try and see if I can find a shop to press out the pinion and bearing for me. (Local shop couldn't press it out with a 20-ton press) I think I can then find a bearing and seal to rebuild the extra half case and have it as a spare or resell. There is not a lot of information available on the rear ends for the Z3's available and parts are almost impossible to find. That is probably why I couldn't find any shops locally to try and rebuild the one from the car. I couldn't even find a rebuilt or new differential available but did find a couple of used ones. Only problem is that the 96-98 Z3 used a combination of about 9 different rear ends and the majority of them are for Automatic transmission. I guess that even then manual transmissions were not in style. UPDATE: No luck in finding a shop to repair or even the parts needed. I ended up buying a used rear end and installing it. Wasn't too hard but applying torque to the top mounting bolts were a bitch. AND THE BEAT GOES ON.

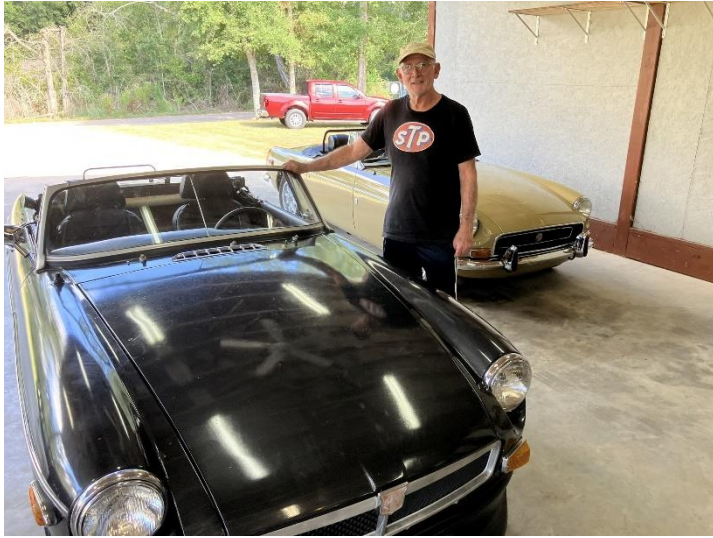
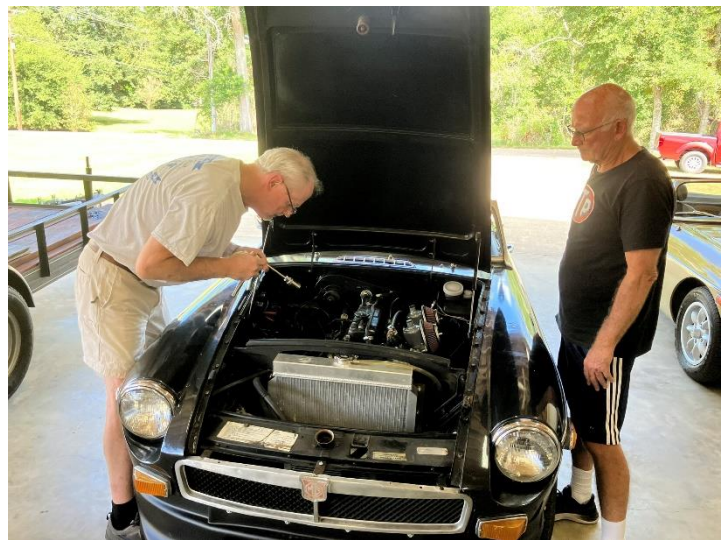
Rob Adair, a friend of EMC has acquired a badly neglected 1974 MGB Roadster. Overall the car was in pretty good shape in spite of its neglected history.

So far Rob has replaced the floor boards, fixed some wiring issues, replaced the interior, and rebuilt the front suspension. He got the engine running pretty good after cleaning out the fuel system and adjusting the valves. Most recently he removed the Weber carb conversion and went back to a pair of Joe Curto rebuilt SU carbs. For final tuning, Rob enlisted the expert talents of Bro Clay. After getting the carbs balanced an ignition issue was identified. A quick dig through Charlie's "gold

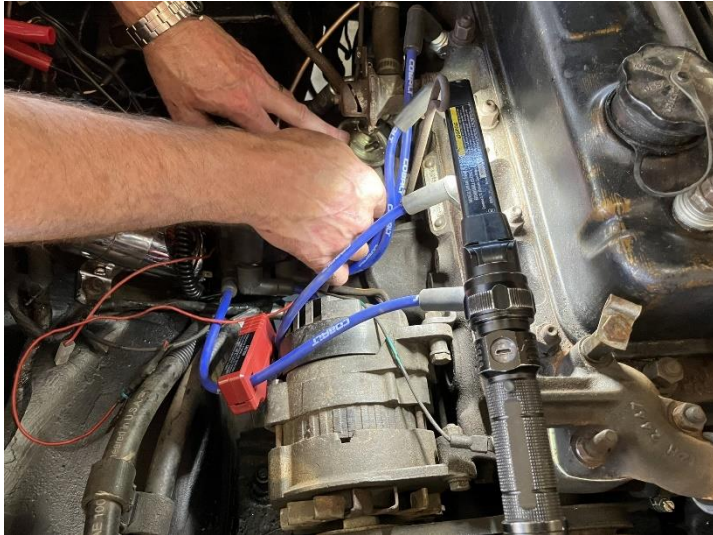
mine” a replacement distributor found. Now the engine runs much better. Also it was identified that someone had installed the distributor drive spindle 180 degrees out. Since Rob has a new replacement distributor inbound, the drive

spindle will be reoriented when the distributor is replaced.
We hope to see Rob and his new to him MGB at an upcoming EMC event.
